6. The conservation of a reverse painting on glass depicting Charles Stewart Parnell

Damian Lizun

This paper presents the conservation issues that concern the glass reverse painting 'Charles Stewart Parnell' by an anonymous painter, executed in the late nineteenth or early twentieth century. The paper will outline the technique, condition and complex conservation treatment of the object. The painting before conservation was in a poor state of preservation owing to material degradation and previous unprofessional attempts at restoration. The glass support was broken in three parts. The paint layer was severely delaminated. Poor repairs and damages were visually disturbing the painted scene. It was essential to carry out a technical examination and detailed condition assessment in order to consider different conservation approaches. The conservation process involved treatment both of the glass support and of the painting layer. A critical issue was edge-gluing treatment and reintegration of the painting layer.

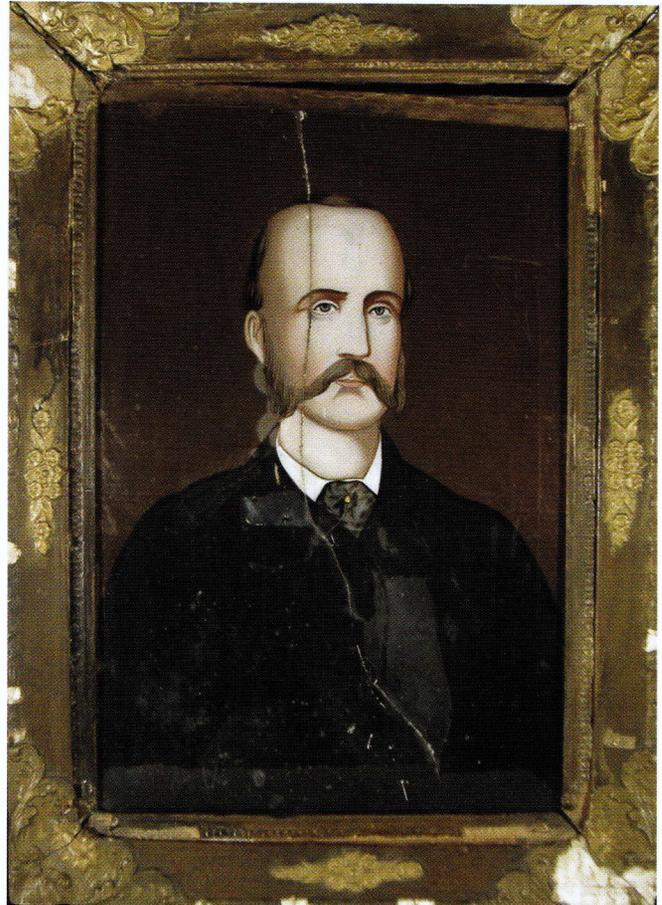
The glass support was broken in three parts. The glass edges alongside the cracks had many tiny chips. Previous attempts at restoration of the painting, which have proved unsatisfactory, resulted in further damage. The reverse of the broken glass support was reinforced by means of thick cardboard that had been attached with a heavy application of synthetic glue. This treatment resulted in greater adhesion between glue and original paint than between the paint and the glass. In effect, there were broad areas where the paint layer was completely detached. The largest area of separation of paint from the glass was on the black jacket in two flakes. The next largest was on the brown background near the right side of the neck. Another type of damage was paint delamination in the form of tiny flakes of various sizes. They were observed on the black jacket, brown background and alongside the glass cracks. Generally, when viewed from the front, the paint delamination

Fig. 1—Charles Stewart Parnell. A glass reverse painting with frame, before conservation. The glass panel was broken in three parts.

In the next stage, surface dirt from the paint layer was removed using 3% tri-ammonium citrate. After cleaning, the glass repairs were carried out. All the glass edges were cleaned by scraping off any residual dirt and adhesive, and then were degreased with acetone. The edges were glued using the two-part low-viscosity epoxy resin Hxtal NYL-1,¹⁰ which has a very similar refractive index (R.I. 1.5201) to the glass (1.520). First, the smallest piece of glass was joined to the left half of the painting. Then, when the joint cured, the two biggest halves of the painting were joined together and left under the even pressure of a glass slab for 48 hours. Then the joint was cleaned up, using a scalpel blade to scrape off the excess resin, and then polished with Greygate perspex polish paste. Gluing the edges did not produce a completely invisible line. The break in the bottom section in the area of the black suit is readily visible because the front side of the glass edges alongside the cracks have many tiny chips. The upper section of the repair is almost invisible.

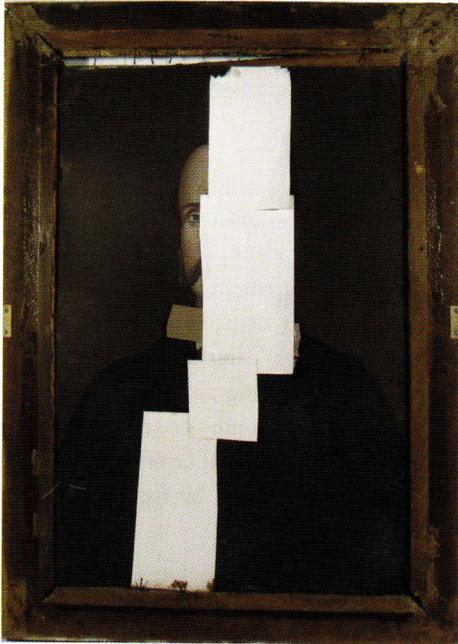
Fig. 2—The back of the painting before conservation. Cardboard and synthetic adhesive were used to reinforce the broken glass panel during amateur repair.

The painting was securely taken off the frame and surface dust was brushed away. Then tests were carried out to identify the type of glue used to reinforce the broken glass support. The glue was sensitive to organic solvents like acetone and toluene, and also turned out to be flexible when hot water was applied. The organic solvents, which were tested, were very effective in dissolving the glue but had a major disadvantage. The glue became very sticky and thus difficult to remove. It could also have started to penetrate into the paint layer. The paint layer was not chemically inert to the solvents. Finally, the 'water method' was chosen to remove the backing with adhesive, using a hot steam generator. This method guaranteed a fully controlled, gradual application of hot steam to soften the cardboard and then the adhesive from most of the areas. The

moistened cardboard was gradually removed mechanically with a scalpel blade. Then some loose, fully delaminated large flakes of paint with adhesive on the back were released and carefully removed for further research and treatment. In the following stage, the adhesive layer on the painting was softened with hot steam and carefully rolled off. This could not have been applied to the already detached large flakes with adhesive on their back.

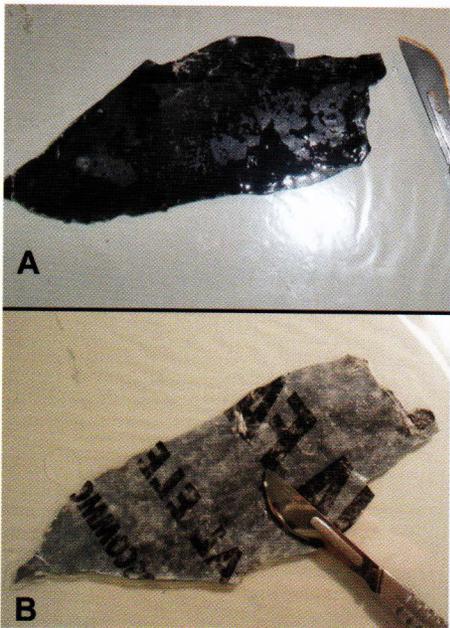
Fig. 4—One of the large flakes after detachment. The front of the paint is penetrated by the adhesive, causing changes of colour and colour saturation (A). The back of the flake is completely covered with adhesive and residues of the paper fibres (B).

The conservation process had to involve treatment of both the glass support and the paint layer. The most challenging treatment decision related to the paint layer. In many cases in the area of previous restoration, the adhesive penetrated the large paint flakes through the pores and partially laminated them from both sides, so that the front of the flakes had different colour saturation. Three differing approaches presented themselves:

In the next stage, suitable treatments were carried out to address the problem of the detached large flakes. After macroscopic examination only one large flake was chosen for reattachment. The reattachment was carried out using 10% Aquazol 500 in distilled water. A serious concern was retouching the missing areas of paint. Retouching the paint layer on glass is a very difficult task because the thickness and slight coloration of the glass itself can alter applied colours when viewed through it. Sandra Davison presented a review

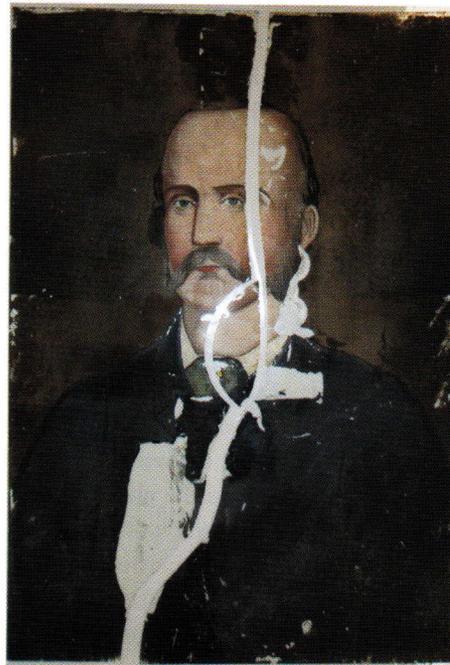
Fig. 5—The back of the painting after paper and adhesive removal. The three pieces of broken glass were separated. Loose, large flakes of delaminated paint were safely detached.

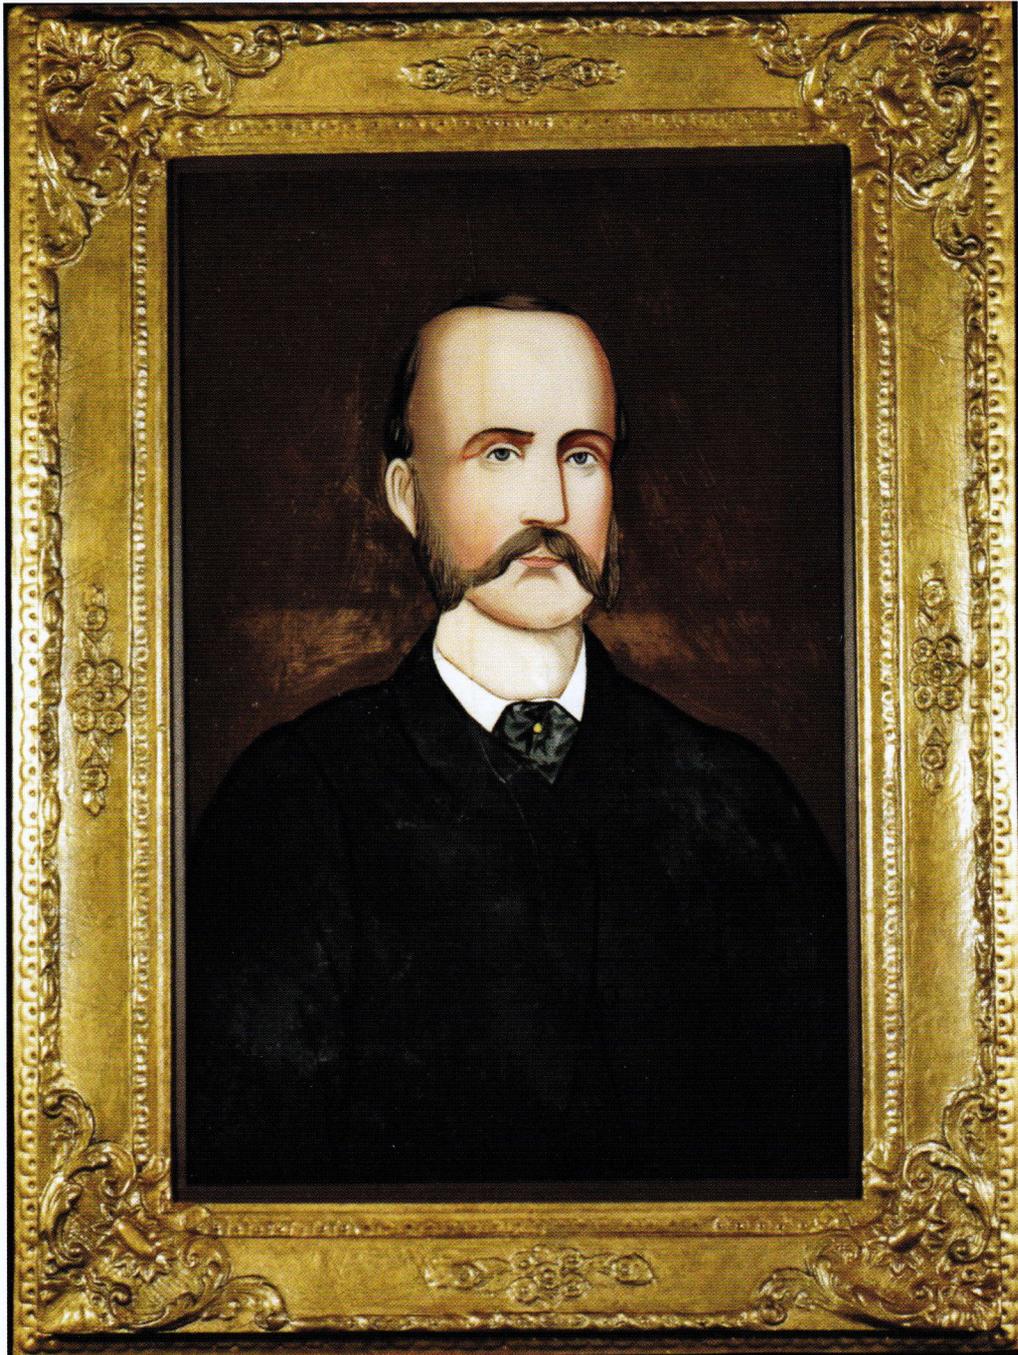
Fig. 6—The painting and frame after conservation.

The original frame belonging to the painting was padded with archival polyethylene foam so that the glass would fit more snugly into its frame. In the end a corrugated plastic sheet was inserted behind the backboard.
